TECHNICAL MEMORANDUM

Subject: Pacheco Boulevard Improvements
Blum Road to Morello Avenue

SURVEY REPORT

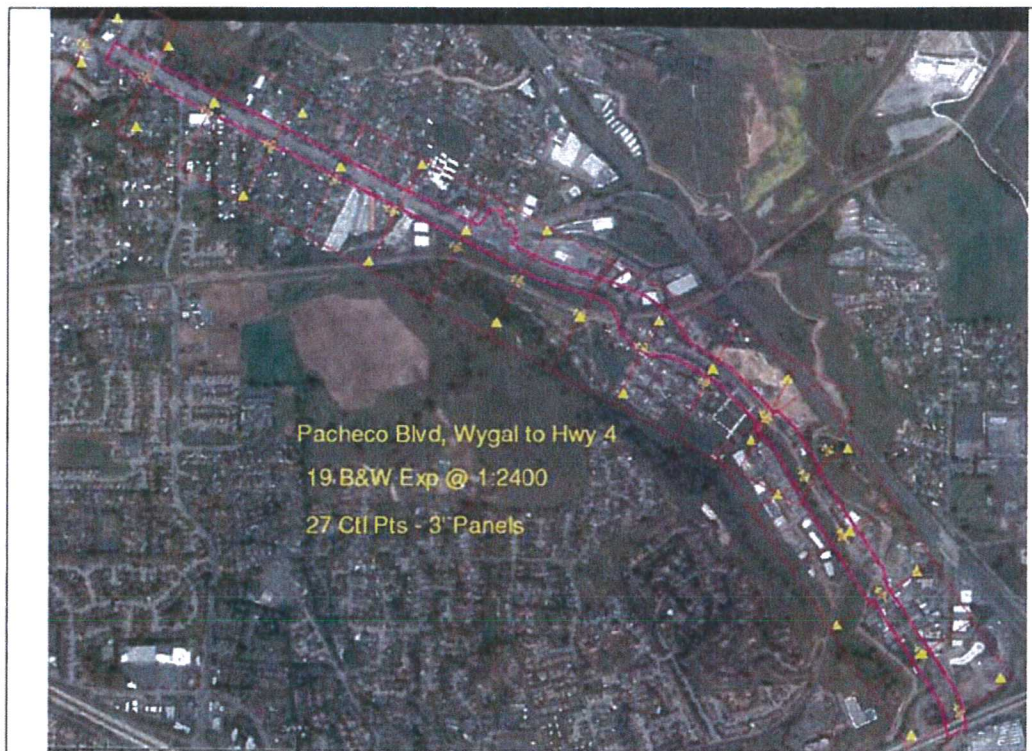
PROJECT DIAGRAM

Survey Control: LCC provided the 27 ground control points generally shown on Figure 1. The flight crosses were generally 3 feet corner to corner by 3 inches wide.
